# **KALEIDO SOFTWARE**

Version 9.22

## **Release Notes**

M770-2103-187

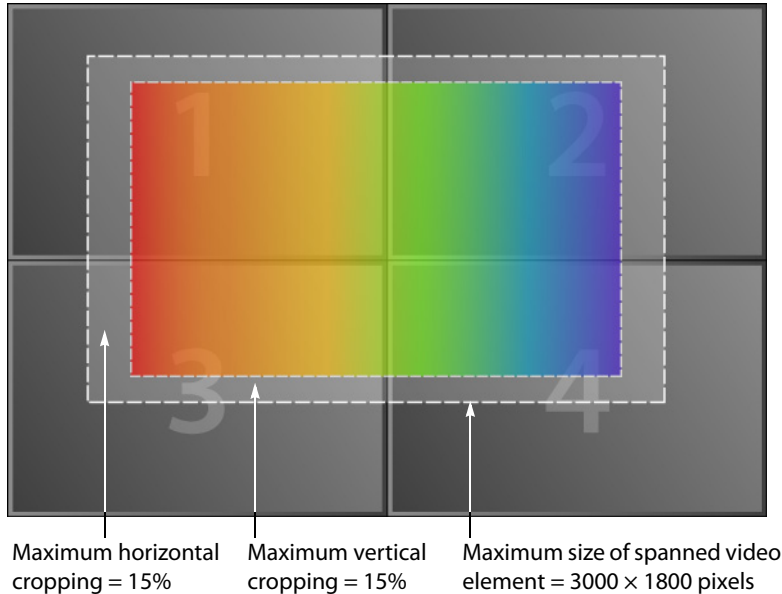
- [Ref. #KX-2270] **Kaleido-X, Kaleido-X16:** excessive scaling of video elements results in a loss of video image on a monitor wall. This can be caused by loading a complex layout with a video monitor or full screen zone spanning two or more displays. The problem can be made worse by overlapping elements.

**Note:** Even if a spanned video monitor does not exceed the recommended maximum size, the problem could occur if it is set to follow AFD/WSS with a custom cropping of (15, 15, 15, 15).

*Workaround:* Keep full screen zones within a single display. Do not span a monitor beyond a maximum of 3000 × 1800 pixels. When spanning or scaling video monitors in a layout, avoid heavy cropping settings (generally avoid exceeding 15% in any direction). If the problem persists in full screen layouts, try reducing the scaling settings further.
