EAP-3901/EAP-3101

Upgrade Package Release History

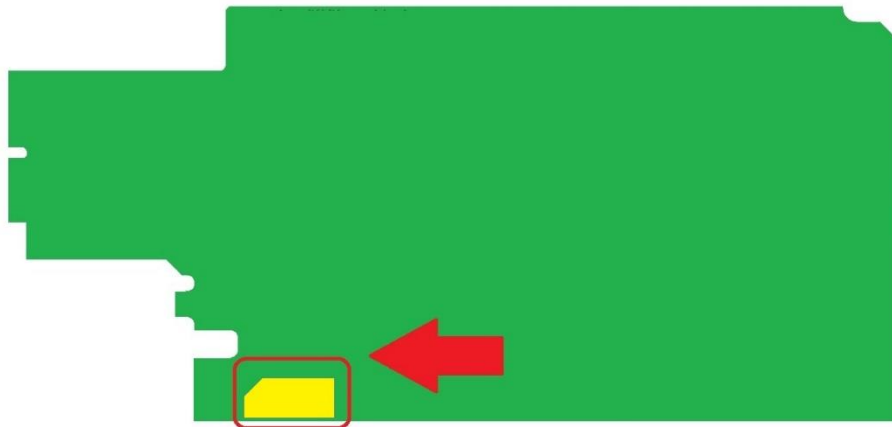
The assembly based on PCB Revision 1922-0100-300 introduces a new dataflash model, supported by release 3.1.4 (firmware: 3.1.3) and later. While release 3.1.4 can be installed on assemblies using older PCB revisions, older releases are not compatible with PCB revision 1922-0100-300.

See below for location of the PCB revision number
