KALEIDO SOFTWARE

Version 9.00

Release Notes

M770-2103-179

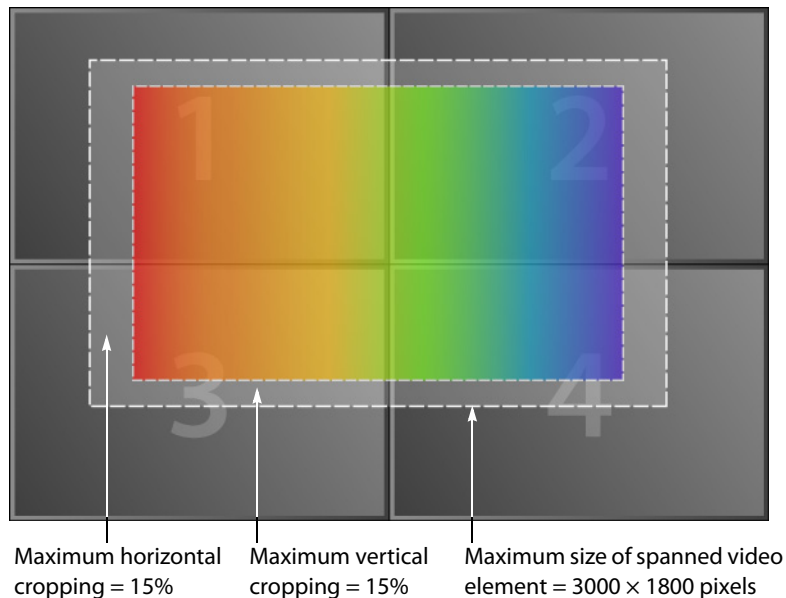
- [Ref. #KX-2270] **Kaleido-X, Kaleido-X16:** excessive scaling of video elements results in a loss of video image on a monitor wall. This can be caused by loading a complex layout with a video monitor or full screen zone spanning two or more displays. The problem can be made worse by overlapping elements.
Workaround: Keep full screen zones within a single display. Do not span a monitor beyond a maximum of 3000 × 1800 pixels. When spanning or scaling video monitors in a layout, avoid heavy cropping settings (generally avoid exceeding 15% in any direction). If the problem persists in full screen layouts, try reducing the scaling settings further.

Note: Even if a spanned video monitor does not exceed the recommended maximum size, the problem could occur if it is set to follow AFD/WSS with a custom cropping of (15, 15, 15, 15).
