KALEIDO SOFTWARE

VERSION 11.6.1

Release Notes

M770-2103-215

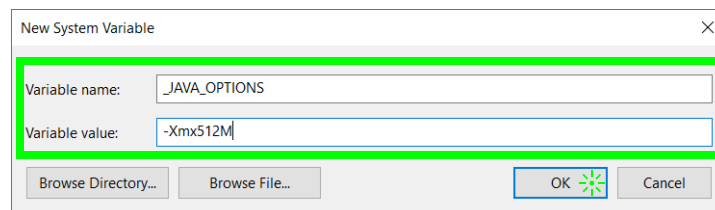
4 Under *System variables*, click *New*.

5 Set the *Variable name* parameter to `_JAVA_OPTIONS`

6 Set the *Variable value* parameter to `-Xmx512M`
