Profile XP System Software 4.0.10 Release Notes

Grass Valley Group Product Support	2
Profile XP Media Platform Features	3
What's new in Version 4.0.10?	
Tips	6
Using Channels in applications	
VdrPanel	
Tool Box Editor	
List Manager	
TimeDelay	
About Time Remaining	
Important RAID considerations	
Updating your PFC500 firmware	
Using redundant RAID controllers	
Configuring NetCentral XP	
Performance information	
Fibre Channel network compatibility	
Fibre Channel RAID storage	
Software installation	
Installing Profile XP System Software 4.0.10	
Updating the RS-422 interface board device driver	
Removing the existing RS-422 device driver	
Installing the RS-422 Board Device Driver	
Microsoft Windows NT support	
Known problems	
Startup	
Recording	
Video	
Audio	
Profile Applications	
Configuration	
Fibre Channel	
Disk Management	26
Profile Protocol	26
Louth Protocol	26
Odetics Protocol	26
APIs	27
Diagnostics

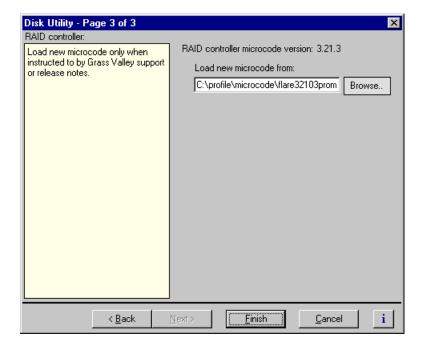
- 1. Start Configuration Manager and choose File System.
- 2. Click **Next** twice to open the third page, Disk Utility.
- 3. In the Disk Utility Page 3 of 3, browse for the latest RAID microcode file in the \RAID_Firmware directory on the CD-ROM. Select the .bin file with the highest "flare" or "prom" version number. For example, flare32104prom202.bin is more recent than flare32103prom202.bin and flare32103prom203.bin is more recent than flare32103prom202.bin.
- 4. Click Finish and wait for the microcode to load.

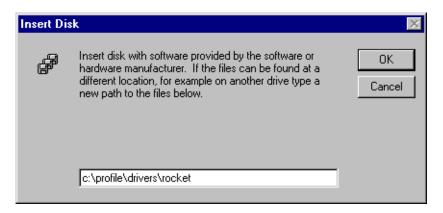
Figure 1. Type the path to the device driver files

- 1. Make sure you are logged on as *Administrator*. The factory default password on the Profile system for *Administrator* is *triton*.
- 2. Open the Control Panel by choosing Start | Settings | Control Panel.
- 3. Double-click the **Network** icon.
- 4. The Network dialog box appears. Click the **Adapters** tab.
- 5. Click the Add button, and then the Have Disk... button.
- 6. When you are prompted, type **c:\profile\drivers\rocket** as the path of the directory containing the driver files (see Figure 1) and click **OK**.

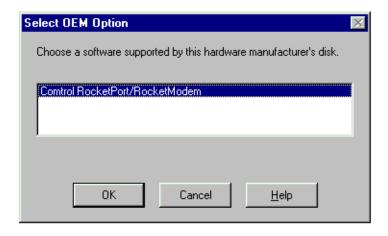
Figure 2. Select the RocketPort driver.

7. The Select OEM Option dialog box appears (see Figure 2). Ensure that the Comtrol RocketPort RocketModem is selected, then click **OK**.

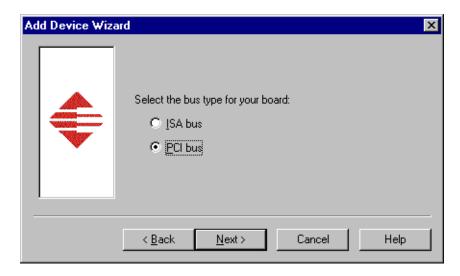
Figure 3. Select the PCI bus type.

8. The Add Device Wizard starts. Click **Next** to continue, then select PCI bus as the bus type (see Figure 3) and click **Next** again.

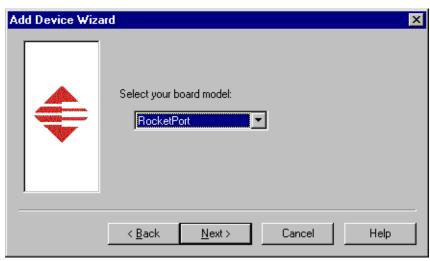
Figure 4. Select RocketPort board model.

9. Select RocketPort as the board type (see Figure 4), then click **Next**.

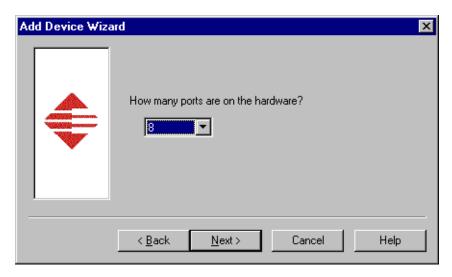
Figure 5. Select eight ports.

10. Select eight ports on the hardware (see Figure 5), then click **Next**.

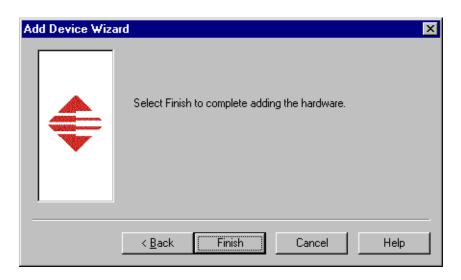
Figure 6. Finish the driver installation.

11. Click Finish to close the Add Devices Wizard (see Figure 6) and open the Device Properties dialog box.

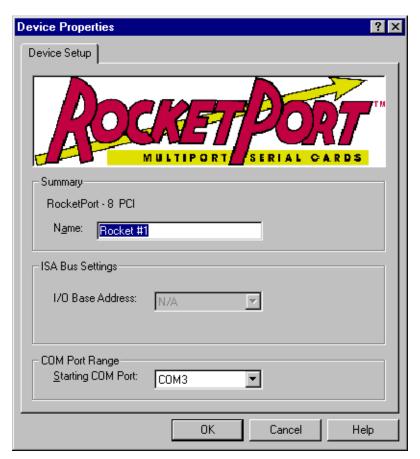
Figure 7. Select COM3 as the starting port.

12. Ensure that the Starting COM Port is set to COM3, then click **OK** to close the Device Properties dialog box (see Figure 7).

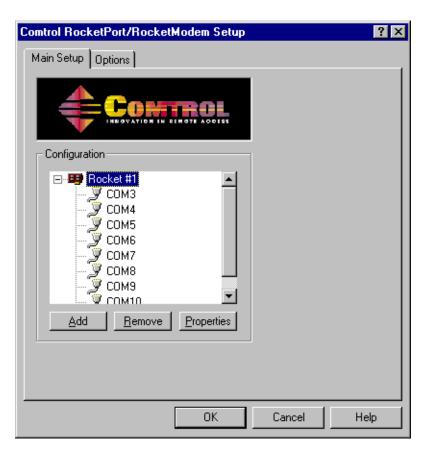
Figure 8. Choose the Options tab.

13. Choose the Options tab in the Comtrol RocketPort/RocketModem Setup dialog box (see Figure 8).

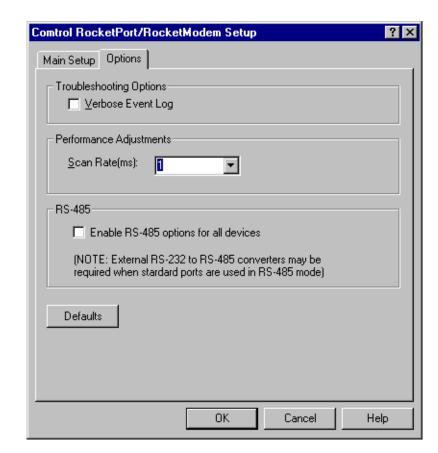
Figure 9. Set the scan rate to 1ms.

14.In the **Options** tab (see Figure 9), set the **Scan Rate(ms)** to 1ms.
