Profile XP System Software 4.0.12 Release Notes

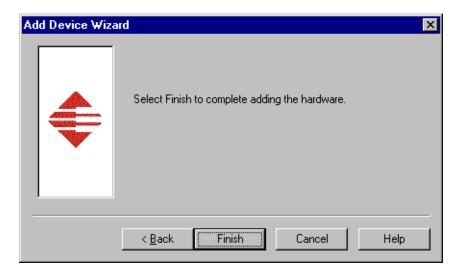
Figure 6. Finish the driver installation.

11. Click Finish to close the Add Devices Wizard (see Figure 6) and open the Device Properties dialog box.
