GV NODE

IP AGGREGATION, PROCESSING AND EDGE ROUTING PLATFORM

Release Notes

Release Notes for GV Node v1.2.5

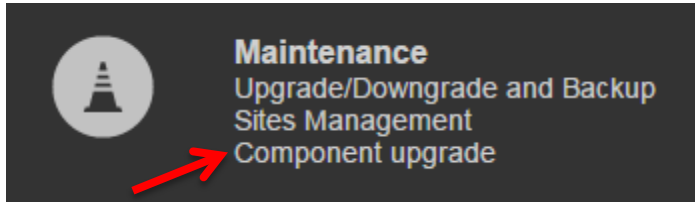
3. Click the "Component upgrade" option in the Maintenance category

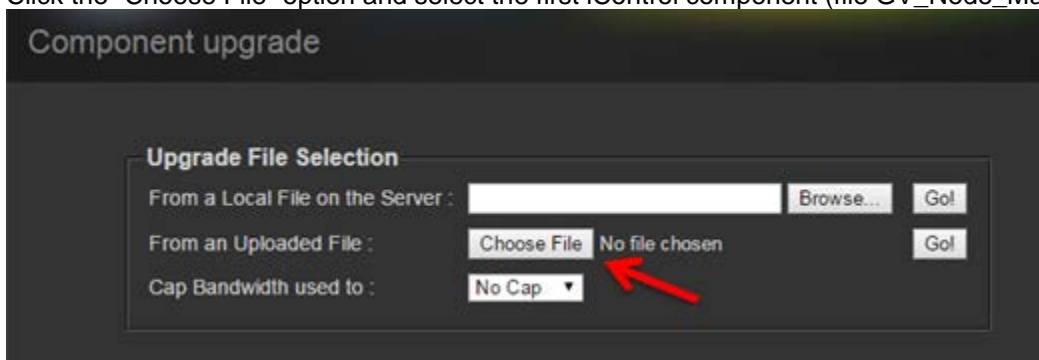
4. Click the "Choose File" option and select the first iControl component (file GV_Node_Manager-1.2_IC7.20.zip)

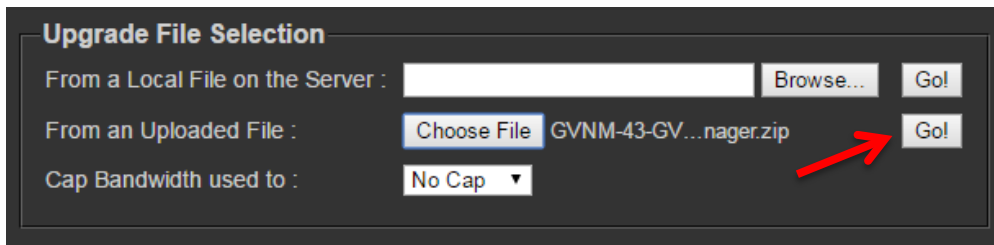
5. Press the Go! Button

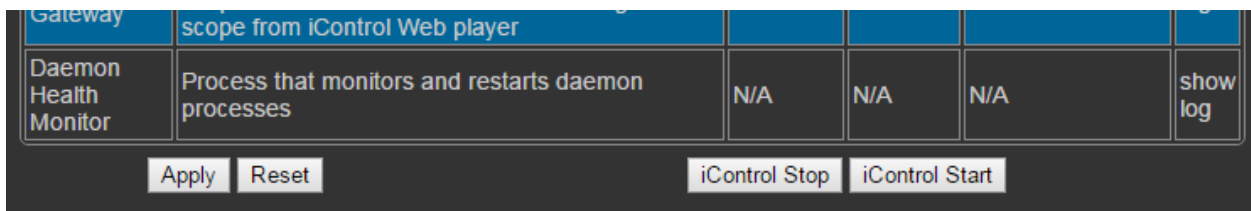
- At the bottom of the page, click iControl Stop”, wait until all services are blue (stopped), then click “iControl Start”.

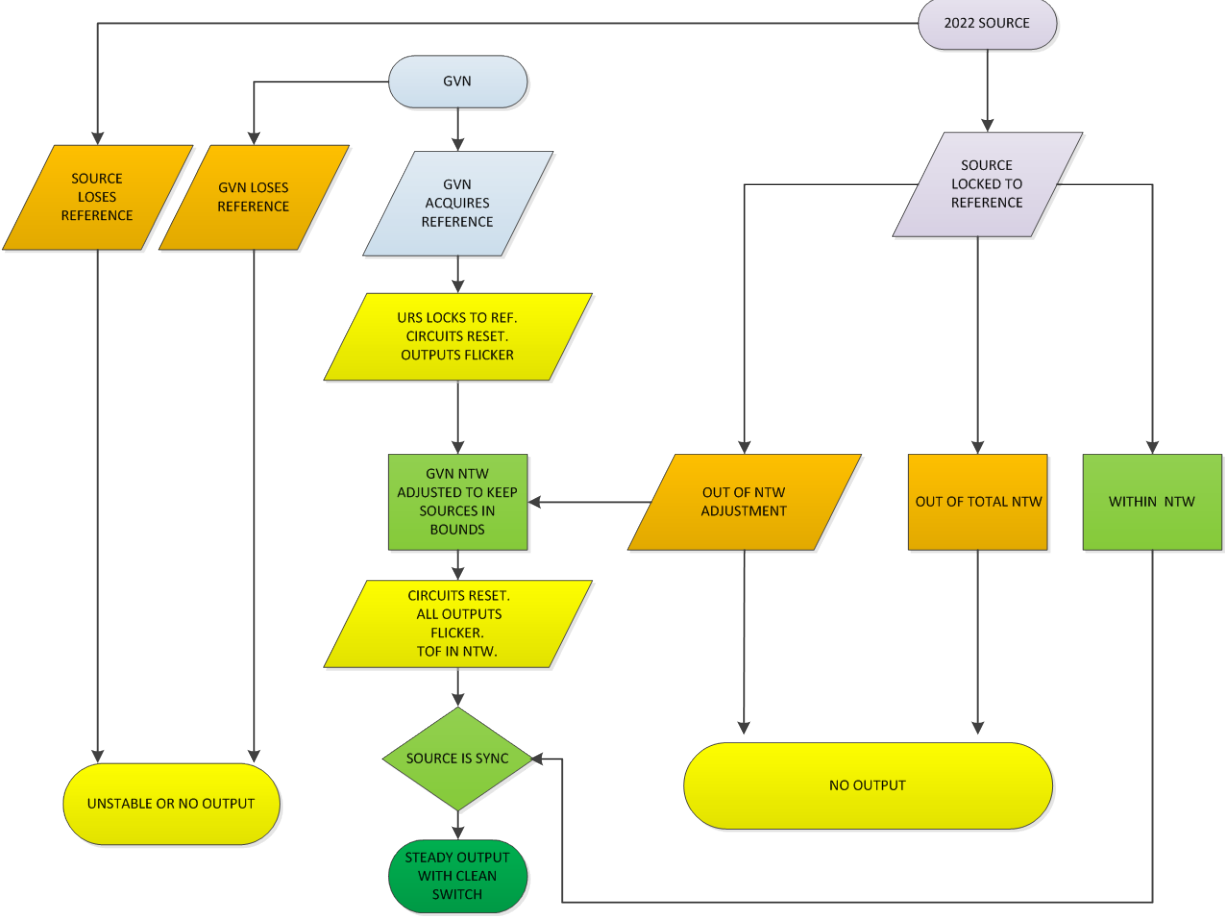
Ref #	Description
IFM-2894	<p>Cannot receive two streams from the same address within a single lane</p> <p>If two RX streams within a single frame are configured with the same address, all streams will stop working on this lane.</p> <p>WORKAROUND: use the internal router to duplicate the source instead.</p>
IFM-3395	<p>Does not support Async sources</p> <p>GVN V1.2 will not pass any signal whose TOF(Top Of Frame) is outside of NTW (Network Tolerance Window). If it is within NTW, the signal will pass and can be clean switched. If the source is freerunning, it may pass at times, but will cause flashes, when the circuit needs to reset to relock.</p> <p>Reference lock and timing adjustment are used to keep signal TOF in NTW.</p>

<pre> graph TD 2022SOURCE([2022 SOURCE]) --> SOURCELOSEREF[/SOURCE LOSES REFERENCE/] 2022SOURCE --> GVNACQUIRESREF[/GVN ACQUIRES REFERENCE/] GVNACQUIRESREF --> URSLOCKS[URS LOCKS TO REF. CIRCUITS RESET. OUTPUTS FLICKER] URSLOCKS --> GVNNTW[GVN NTW ADJUSTED TO KEEP SOURCES IN BOUNDS] GVNNTW --> CIRCUITSRESET[CIRCUITS RESET. ALL OUTPUTS FLICKER. TOF IN NTW.] CIRCUITSRESET --> SOURCEISSYNC{SOURCE IS SYNC} SOURCEISSYNC --> STEADYOUTPUT([STEADY OUTPUT WITH CLEAN SWITCH]) SOURCELOSEREF --> UNSTABLE([UNSTABLE OR NO OUTPUT]) GVN --> GVNLOSESREF[/GVN LOSES REFERENCE/] GVNLOSESREF --> UNSTABLE GVN --> SOURCELOCKED[/SOURCE LOCKED TO REFERENCE/] SOURCELOCKED --> OUTOFNTWADJ[/OUT OF NTW ADJUSTMENT/] SOURCELOCKED --> OUTOFTOTALNTW[OUT OF TOTAL NTW] SOURCELOCKED --> WITHINNTW[WITHIN NTW] OUTOFNTWADJ --> NOOUTPUT([NO OUTPUT]) OUTOFTOTALNTW --> NOOUTPUT WITHINNTW --> STEADYOUTPUT </pre>

<p><u>GVNode has added 1 packet of delay variance.</u></p> <ol style="list-style-type: none">1. Due to the packet usage change from V1.1 to V1.2, it is recommended the Network Tolerance Window be verified.
--	---
