# GV NODE

IP AGGREGATION, PROCESSING AND EDGE ROUTING PLATFORM

## Release Notes

## Release Notes for GV Node

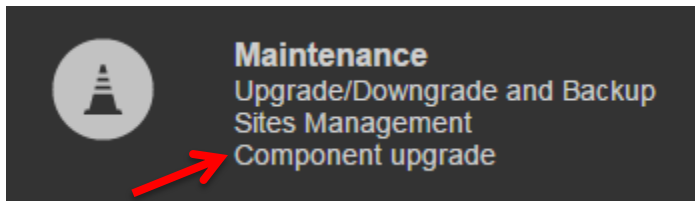
2. Enter username "admin". The default password is "icontrol" if it was not changed. Click "Log In" to proceed.
3. Click the "Component upgrade" option in the Maintenance category

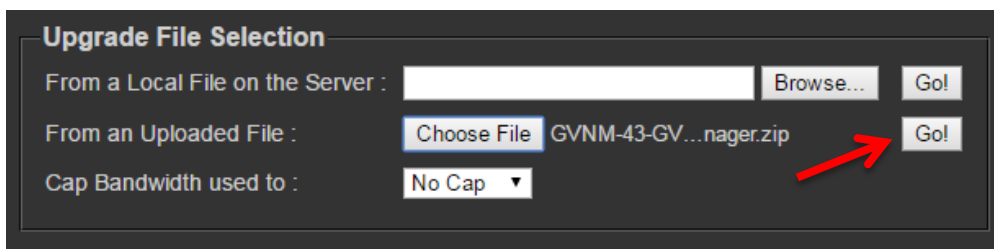
5. Click **Go!**

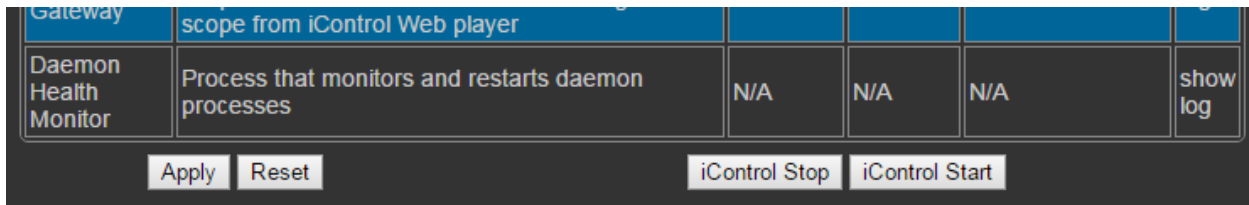
- At the bottom of the page, click “iControl Stop”, wait until all services are blue (stopped), then click “iControl Start”.

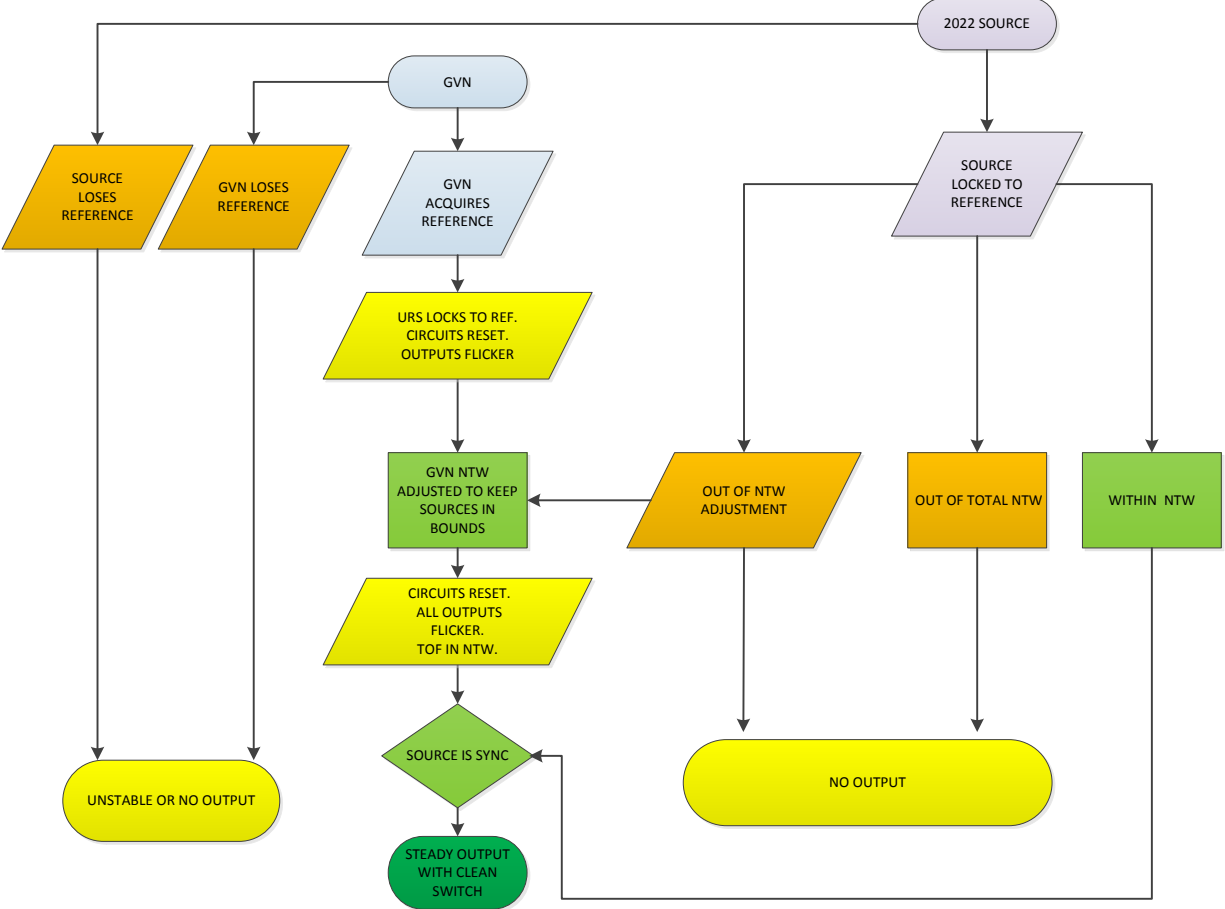
Ref #	Description
IFM-3395	<p><b>Does not support Asynchronous sources</b></p> <p>GVN V1.2 will not pass any signal whose TOF (Top Of Frame) is outside of NTW (Network Tolerance Window). If it is within NTW, the signal will pass and can be clean switched. If the source is free-running, it may pass at times, but will cause flashes, when the circuit needs to reset to relock.</p> <p>Reference lock and timing adjustment are used to keep signal TOF in NTW.</p>

<pre> graph TD     2022((2022 SOURCE)) --&gt; GVN((GVN))     2022 --&gt; SLR[/SOURCE LOCKED TO REFERENCE/]     GVN --&gt; SLL[/SOURCE LOSES REFERENCE/]     GVN --&gt; GVL[/GVN LOSES REFERENCE/]     GVN --&gt; GVA[/GVN ACQUIRES REFERENCE/]     GVA --&gt; URS[/URS LOCKS TO REF. CIRCUITS RESET. OUTPUTS FLICKER./]     URS --&gt; GVN_NTW[GVN NTW ADJUSTED TO KEEP SOURCES IN BOUNDS]     GVN_NTW --&gt; CR[/CIRCUITS RESET. ALL OUTPUTS FLICKER. TOF IN NTW./]     CR --&gt; SIS{SOURCE IS SYNC}     SIS --&gt; SOS((STEADY OUTPUT WITH CLEAN SWITCH))     SLR --&gt; UNO((UNSTABLE OR NO OUTPUT))     GVL --&gt; UNO     SLR --&gt; OOTW[/OUT OF NTW ADJUSTMENT/]     OOTW --&gt; UNO     SLR --&gt; OTW[OUT OF TOTAL NTW]     OTW --&gt; UNO     SLR --&gt; WNTW[WITHIN NTW]     WNTW --&gt; UNO     </pre>

<p><u>GVNode has added 1 packet of delay variance.</u></p> <ul style="list-style-type: none"> <li>Due to the packet usage change from V1.1 to V1.2, it is recommended the Network Tolerance Window be verified.</li> </ul>
