GV NODE

IP AGGREGATION, PROCESSING AND EDGE ROUTING PLATFORM

Release Notes

Release Notes for GV Node

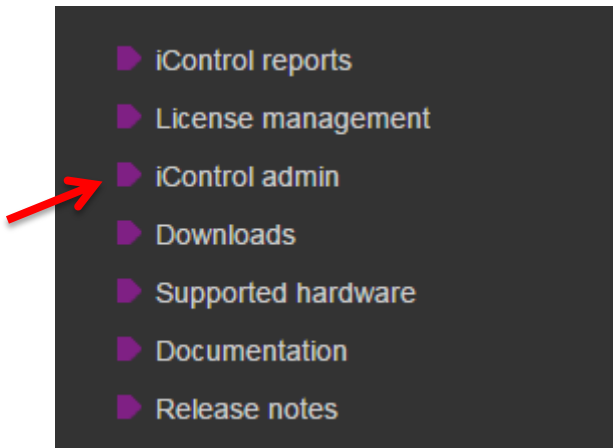
1. From the iControl home page, click on the "iControl admin" option
