Profile System Software 2.5.20 Release Notes

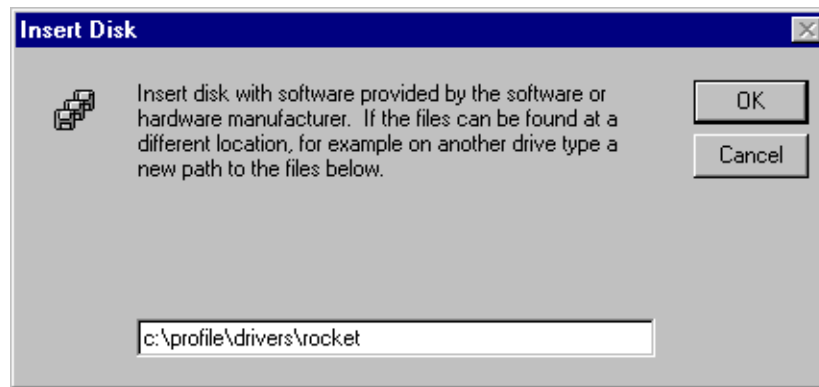
-
2. Open the Control Panel by choosing **Start | Settings | Control Panel**.
 3. Double-click the **Network** icon.
 4. The Network dialog box appears. Click the **Adapters** tab.
 5. Click the **Add** button, and then the **Have Disk** button.
 6. When you are prompted, type **c:\profile\drivers\rocket** as the path of the directory containing the driver files (see Figure 1) and click **OK**.

Figure 1. Type the path to the device driver files

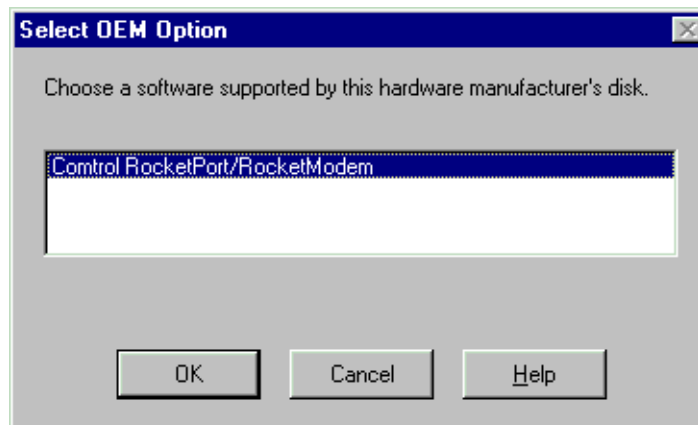
7. The Select OEM Option dialog box appears (see Figure 2). Ensure that the Control RocketPort RocketModem is selected, then click **OK**.

Figure 2. Select the RocketPort driver.

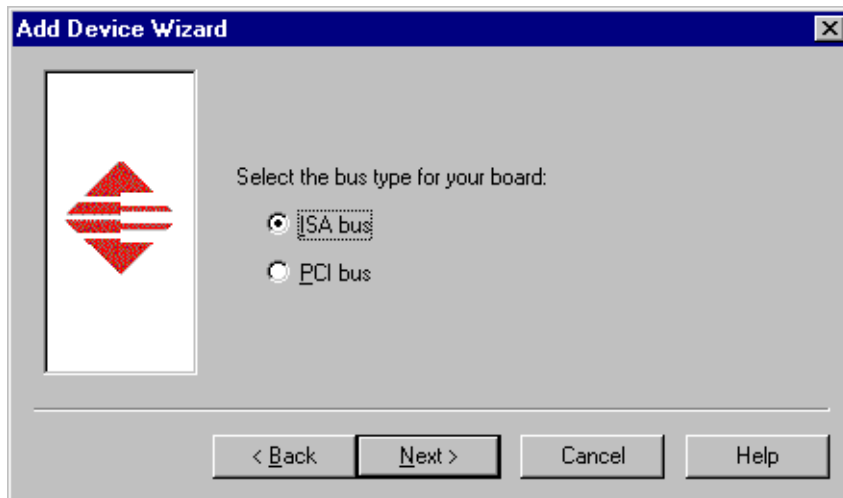
8. The Add Device Wizard starts. Click **Next** to continue, then select ISA bus as the bus type (see Figure 3) and click **Next** again.

Figure 3. Select the ISA bus type.

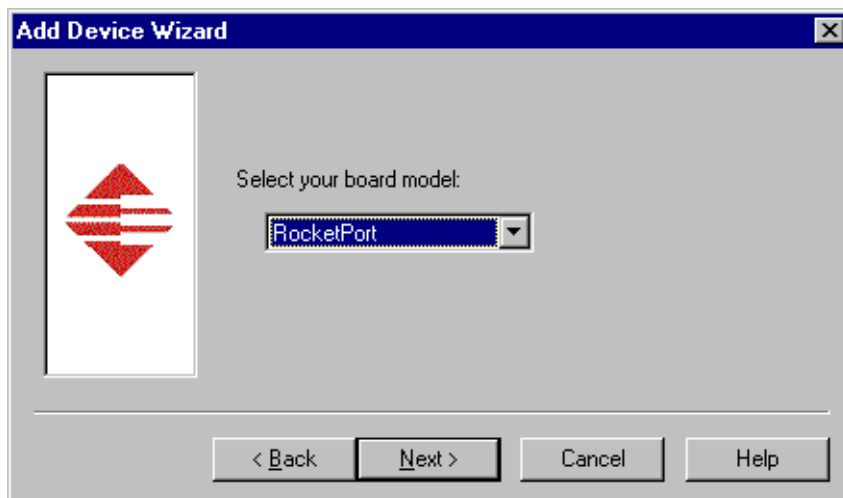
9. Select RocketPort as the board type (see Figure 4), then click **Next**.

Figure 4. Select RocketPort board model.

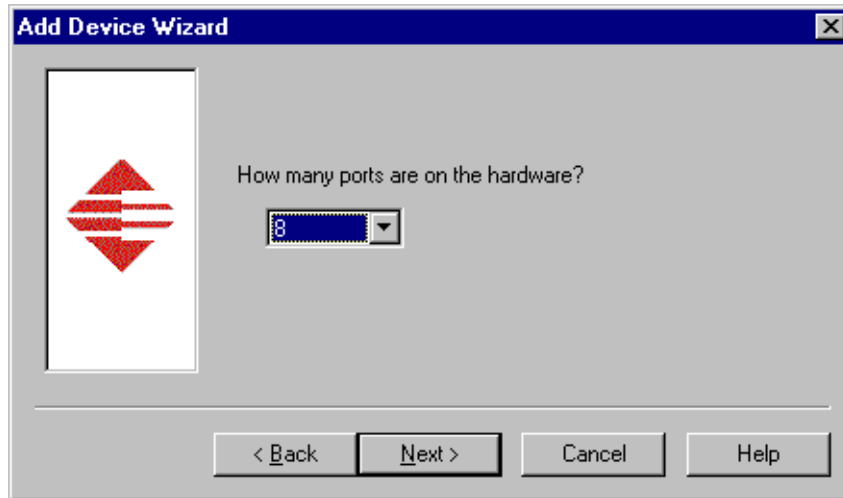
10. Select eight ports on the hardware (see Figure 5), then click **Next**.

Figure 5. Select eight ports.

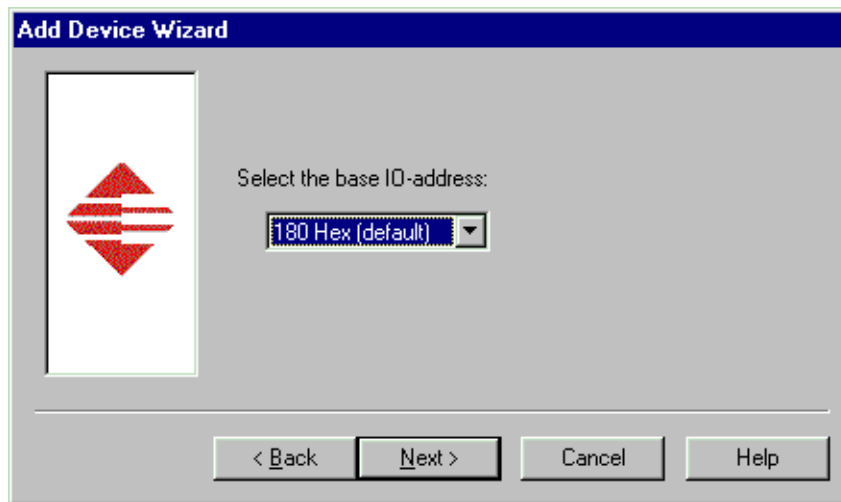
11. Set the I/O Base Address to 180 Hex (see Figure 6), then click **Next**.

Figure 6. Set the I/O Base Address to 180.

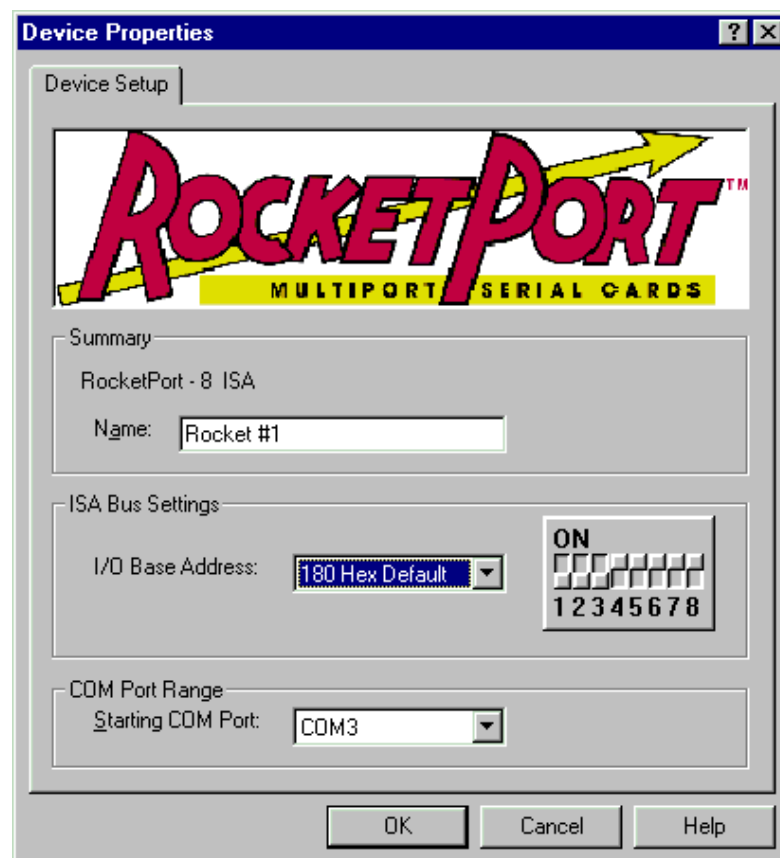
13. Ensure that the Starting COM Port is set to **COM3** and that the I/O Base Address is set to **180 Hex**, then click **OK** to close the Device Properties dialog box (see Figure 8).

Figure 8. Select COM3 as the starting port.

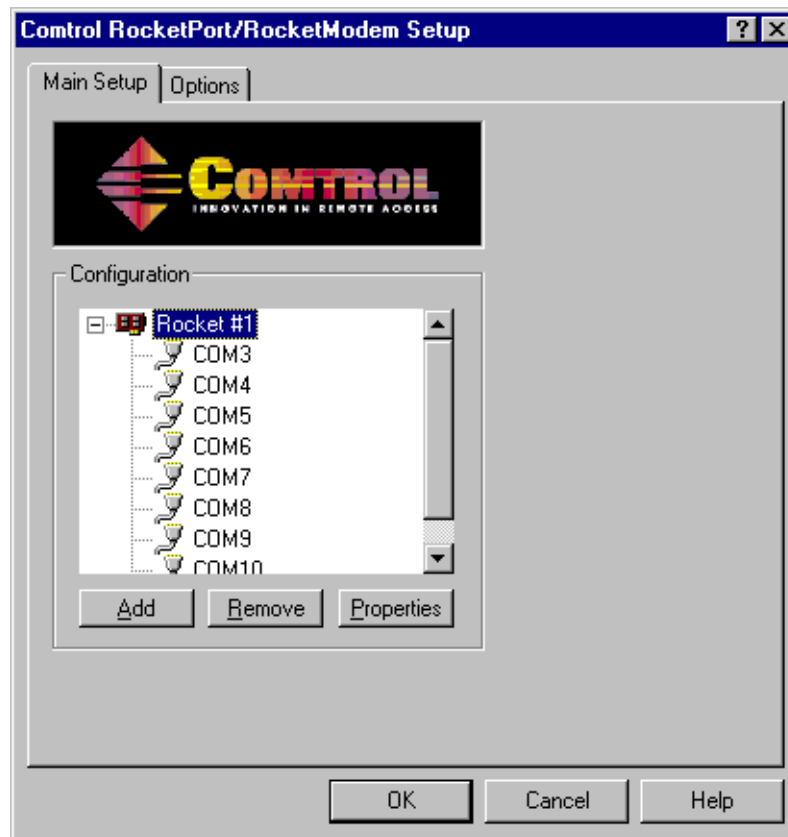
-
14. Choose the Options tab in the Control RocketPort/RocketModem Setup dialog box (see Figure 9).

Figure 9. Choose the Options tab.

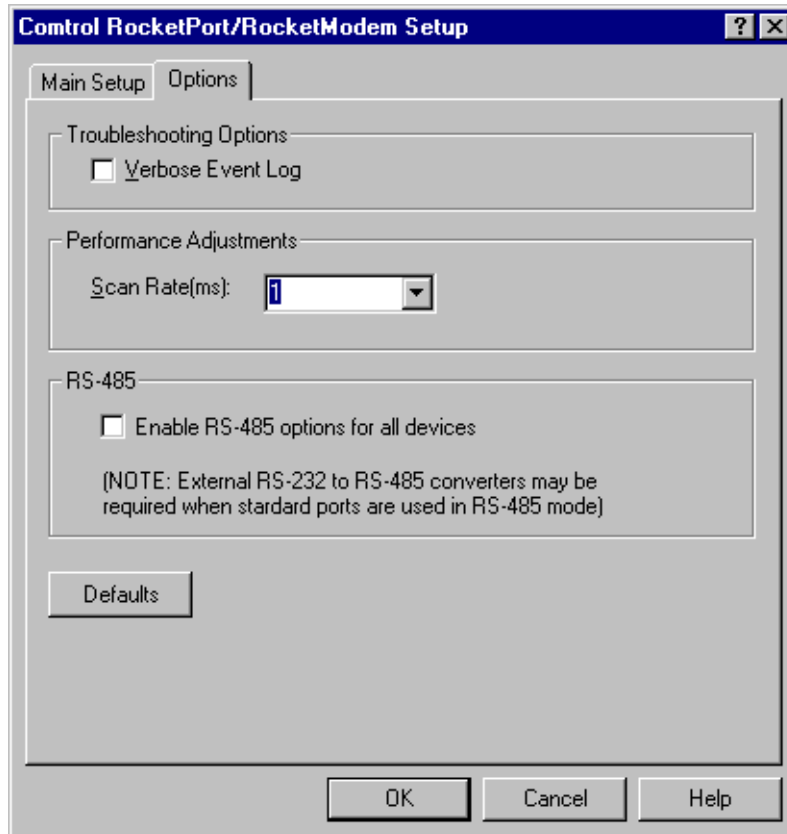
15. In the **Options** tab (see Figure 10), set the **Scan Rate(ms)** to 1ms.

Figure 10. Set the scan rate to 1ms.

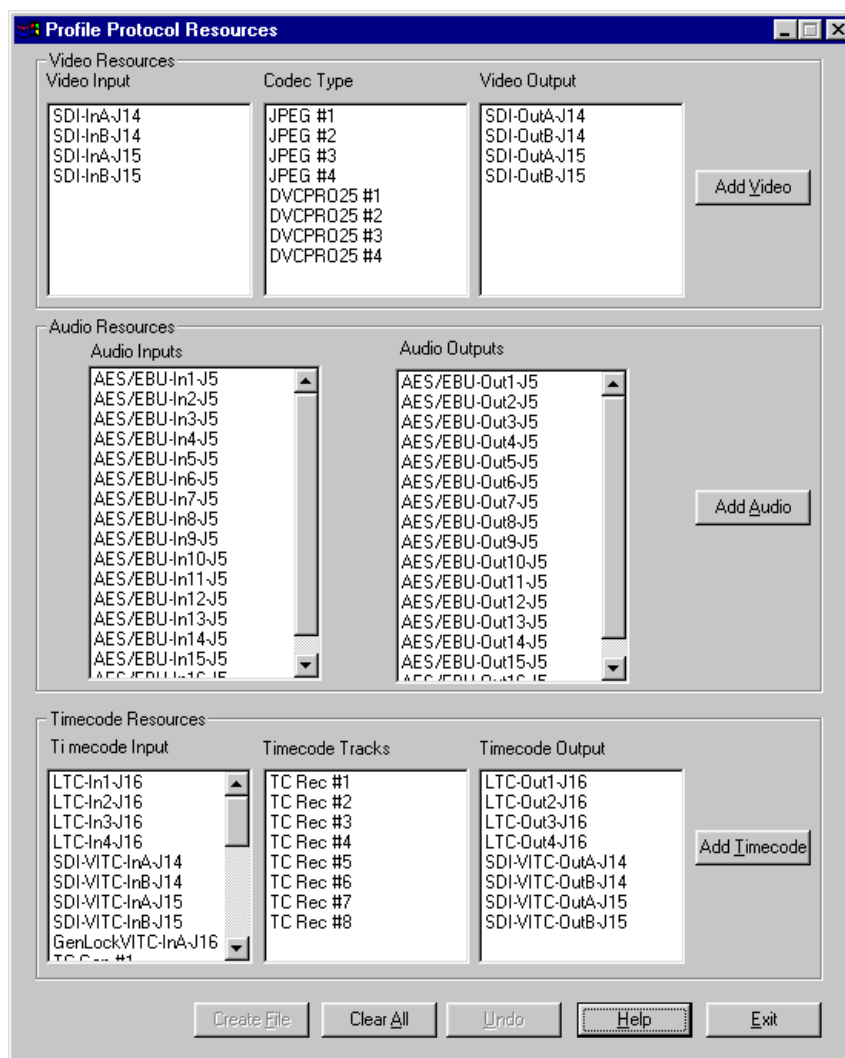
The **Clear** button removes the “Used” tags from resources that have been added but not yet saved; the **Clear All** button clears all “Used” tags in the dialog box, including those for resources that have been saved. The **Create File** button allows you to save the temporarily stored information in the permanent configuration file.

Resources being used by other applications (such as VdrPanel) are tagged as “In Use.” If you wish to add “In Use” resources to the configuration file, exit Profile Protocol Resources, free the resources in the other Profile applications, then restart Profile Protocol Resources.

Figure 11. The main Profile Protocol Resources dialog box

When you start the Profile Protocol Resources utility by double-clicking its icon, a large dialog box similar to the one shown in Figure 11 appears.
