Profile System Software 2.5.23 Release Notes

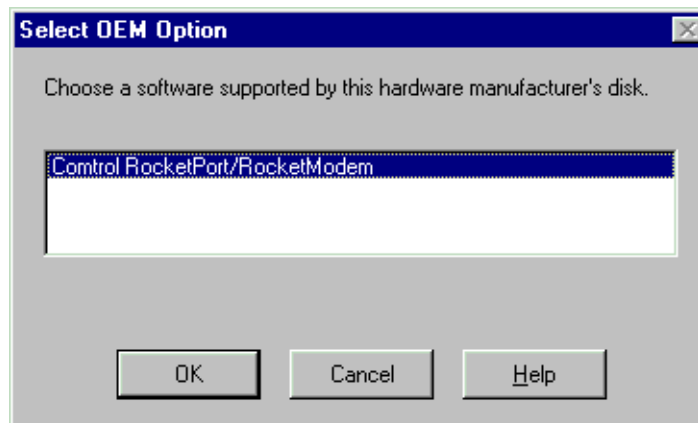
7. The Select OEM Option dialog box appears (see Figure 2). Ensure that the Control RocketPort RocketModem is selected, then click **OK**.

Figure 2. Select the RocketPort driver.

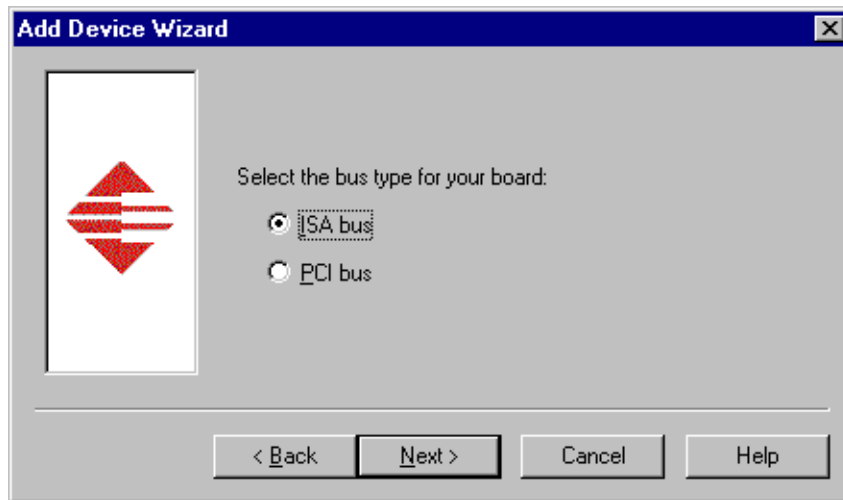
8. The Add Device Wizard starts. Click **Next** to continue, then select ISA bus as the bus type (see Figure 3) and click **Next** again.

Figure 3. Select the ISA bus type.

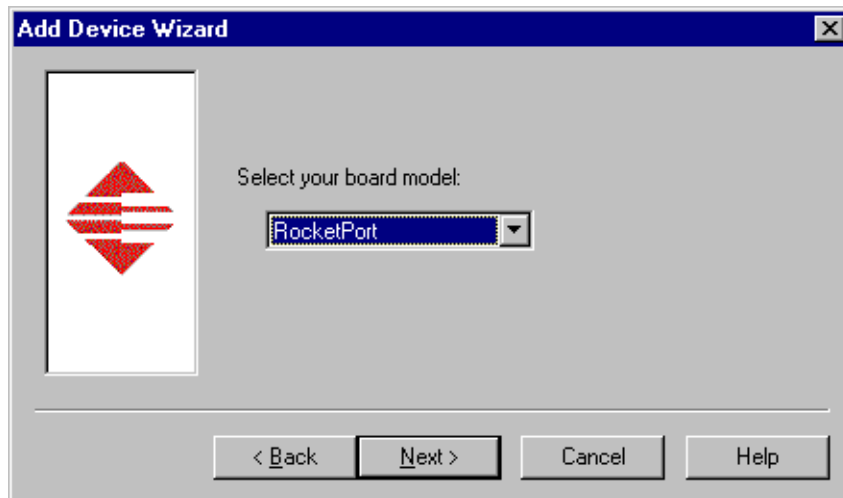
9. Select RocketPort as the board type (see Figure 4), then click **Next**.

Figure 4. Select RocketPort board model.

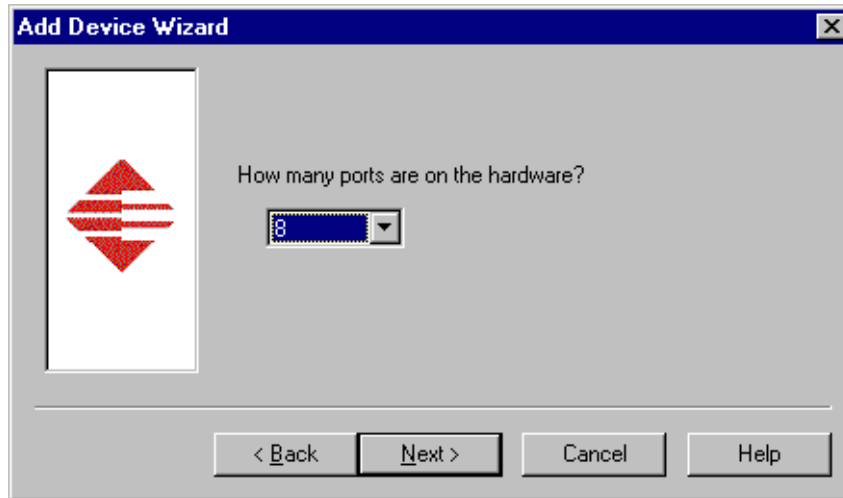
10. Select eight ports on the hardware (see Figure 5), then click **Next**.

Figure 5. Select eight ports.

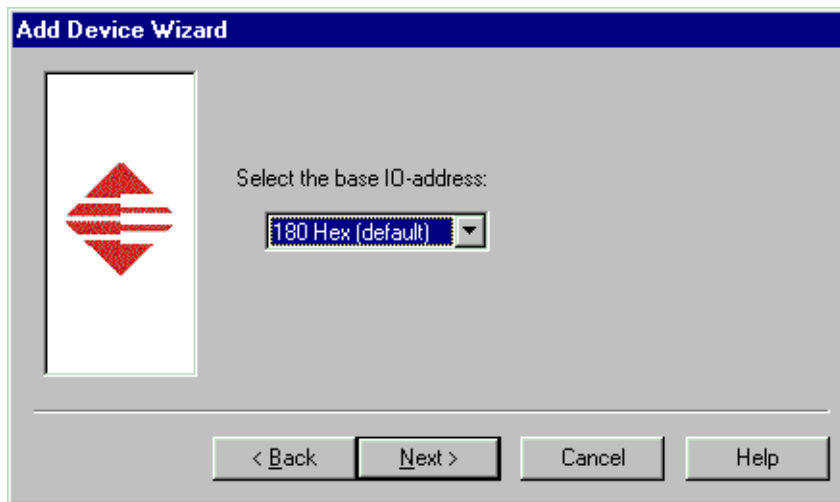
11. Set the I/O Base Address to 180 Hex (see Figure 6), then click **Next**.

Figure 6. Set the I/O Base Address to 180.

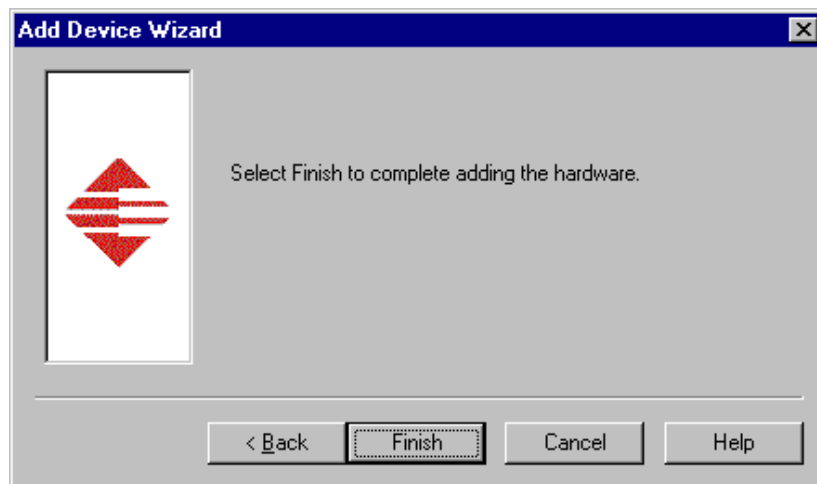
12. Click **Finish** to close the Add Devices Wizard (see Figure 7) and open the Device Properties dialog box.

Figure 7. Finish the driver installation.

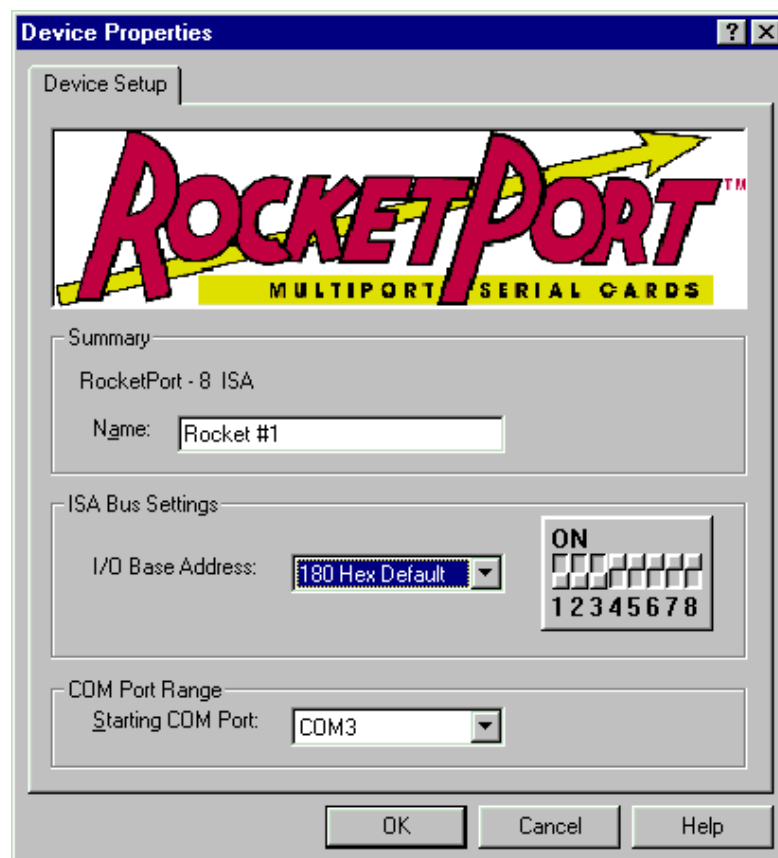
13. Ensure that the Starting COM Port is set to **COM3** and that the I/O Base Address is set to **180 Hex**, then click **OK** to close the Device Properties dialog box (see Figure 8).

Figure 8. Select COM3 as the starting port.

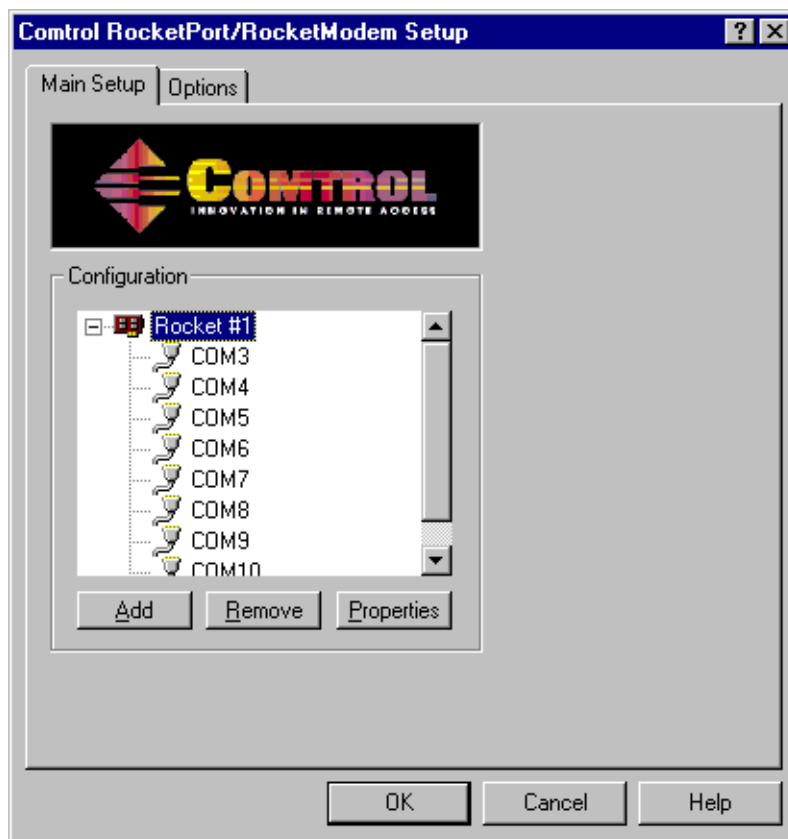
-
14. Choose the Options tab in the Control RocketPort/RocketModem Setup dialog box (see Figure 9).

Figure 9. Choose the Options tab.
