Profile XP System Software 5.4.1 Release Notes

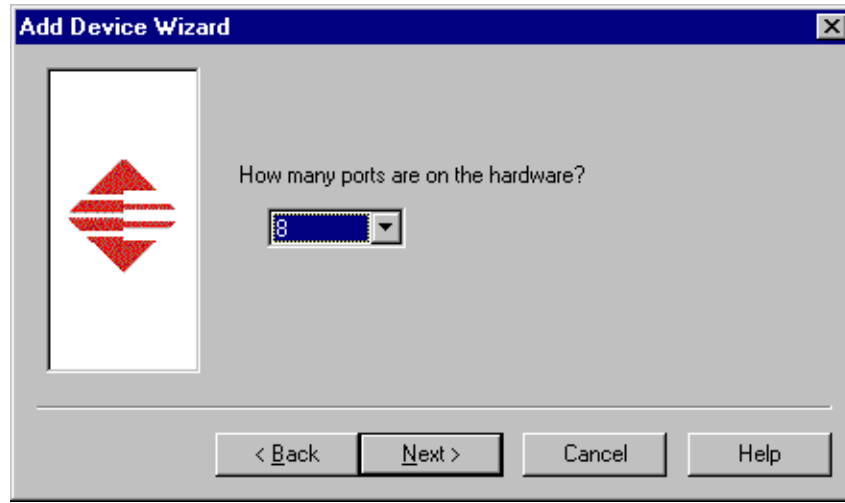
10. Select eight ports on the hardware, then click **Next**.
